47<sup>TH</sup> TURBOMACHINERY & 34<sup>TH</sup> PUMP SYMPOSIA  
HOUSTON, TEXAS | SEPTEMBER 17-20, 2018  
GEORGE R. BROWN CONVENTION CENTER

# Compressor Dry Gas Seal Failure Due To Oil Ingress

Service: RGC, Recycle Gas (Hydrogen)

Location: Hydrotreater, Refinery

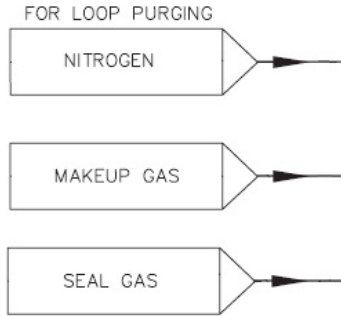
# Failure Analysis

- Make-up gas (Hydrogen) is supplied from a makeup gas compressor discharge, which is a reciprocating machine
- Make up gas compressor has Lubricated cylinder design
- Oil found in the pipeline from Make-up Gas compressor discharge and also in its inter-stage knockout drum.
- Seal gas filter were designed to remove moisture but no safe draining provision in filter housing.
- Above led to oil entry into Dry Gas seal , resulting into its failure

1. Compressor both ends dry gas seals replaced with spare seals, pipe lines cleaned, filters replaced.
2. A dedicated pipeline erected from hydrogen storage bullet to supply clean hydrogen for primary seal during start-ups. Original make-up gas compressor discharge line for primary seal disconnected and blinded off.
3. Safe filter draining provision provided and being drained at regular intervals.
